Inspection Report

Property Address:
123 ABC STREET
Columbia MD 21045

Date: 1/24/2009	Time: 09:53 AM	Report ID: 1-24-09smith
Property: 123 ABC STREET Columbia MD 21045	Customer: Mr. John Smith	Real Estate Professional:

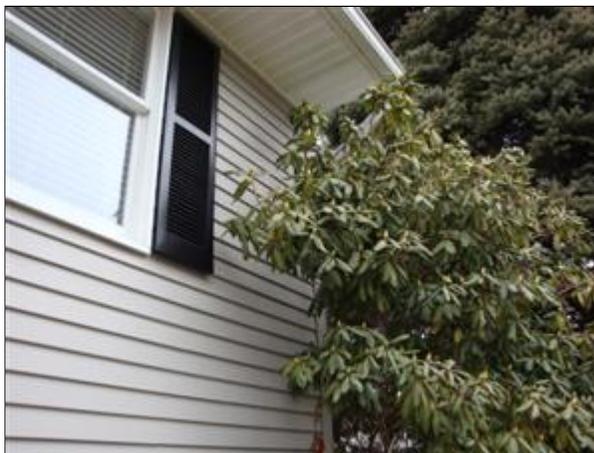
1.1 Picture 1

The tree limbs that are in contact with roof and siding or hanging near roof should be trimmed.

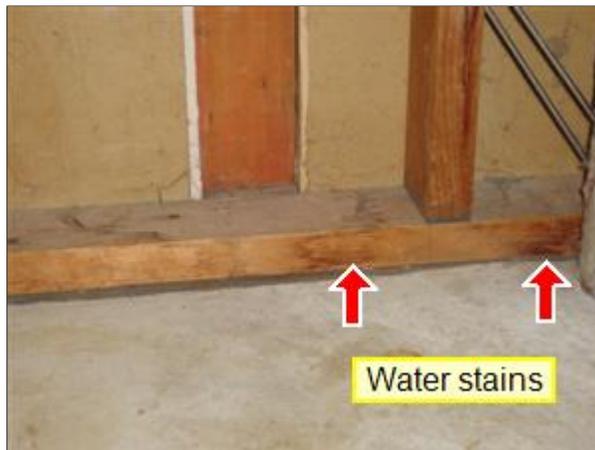
2.1 Picture 1

Visible signs of water intrusion in the basement at the utility room walls are present from water stains on. I am unable to determine the extent of intrusion or how often it occurs. . Check with current owners as to the reason for the water staining.

Visible signs of water intrusion in the basement at the utility room walls are present from water stains on. I am unable to determine the extent of intrusion or how often it occurs. . Check with current owners as to the reason for the water staining.

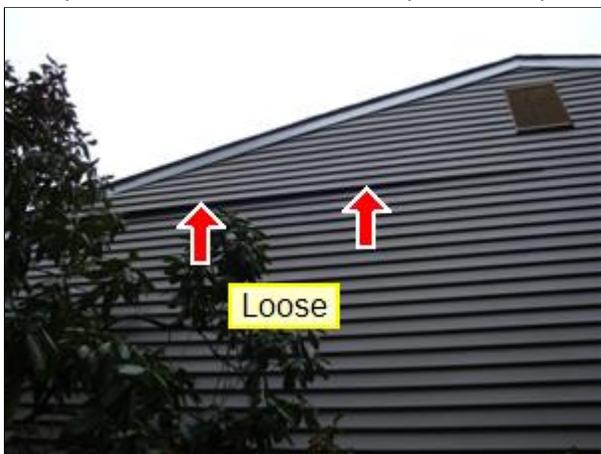
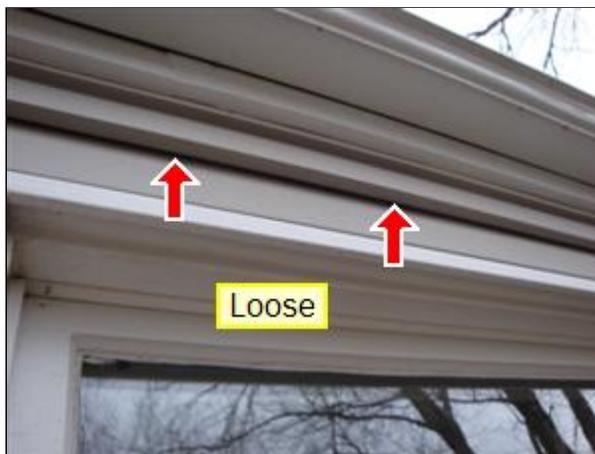
3.0 Picture 1

The aluminum siding at the rear of home and right side (facing front) loose. Further deterioration can occur if not corrected. A qualified contractor should inspect and repair as needed.

The aluminum siding at the rear of home and right side (facing front) loose. Further deterioration can occur if not corrected. A qualified contractor should inspect and repair as needed.

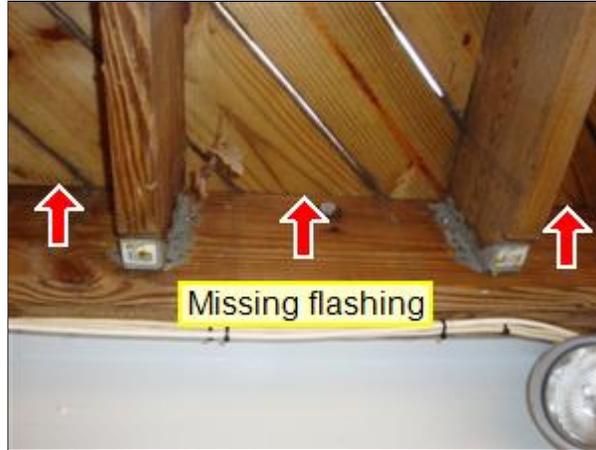
3.3 Picture 1

(1) The deck needs cleaning with a "Deck wash" and seal with a waterproof sealant. Also, do the underside of deck if accessible.

(2) Deck ledger board is not flashed at house. Recommend flashing this area to prevent water penetration at house wall. Have licensed contractor service and certify deck.

(2) Deck ledger board is not flashed at house. Recommend flashing this area to prevent water penetration at house wall. Have licensed contractor service and certify deck.

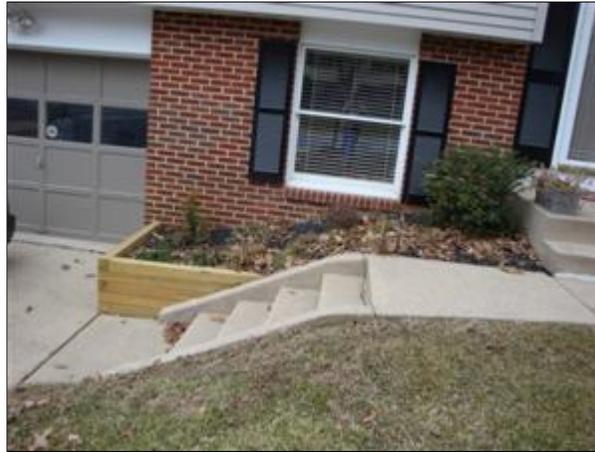
3.3 Picture 2

(3) The guard rail at steps at the front of home is missing. A fall or injury could occur if not corrected. A handrail should be installed for safety.

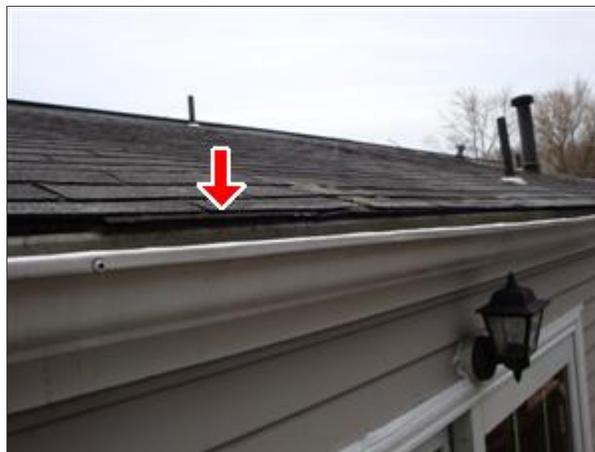
4.0 Picture 1

Roof has several layers of shingles and is beginning to deteriorate. Budget for replacement.

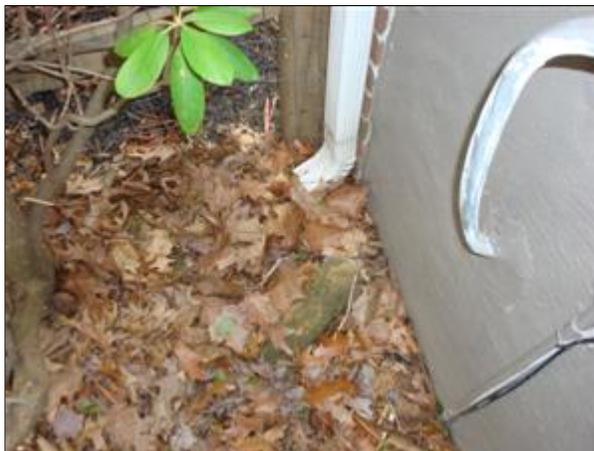
4.1 Picture 1

(1) The downspout at the front (right of main entry) should be extended away from the house. Gutters that drain poorly or clogged can lead to many costly problems such as deterioration of fascia, soffit or roof edge. It can also cause gutters to pull loose and lead to possible water intrusion. A qualified person should repair or replace as needed.

(2) The gutters are full of debris in areas and needs to be cleaned. The debris in gutters can also conceal rust, deterioration or leaks that are not visible until cleaned, and I am unable to determine if such conditions exist.

(1) The downspout at the front (right of main entry) should be extended away from the house. Gutters that drain poorly or clogged can lead to many costly problems such as deterioration of fascia, soffit or roof edge. It can also cause gutters to pull loose and lead to possible water intrusion. A qualified person should repair or replace as needed.

(2) The gutters are full of debris in areas and needs to be cleaned. The debris in gutters can also conceal rust, deterioration or leaks that are not visible until cleaned, and I am unable to determine if such conditions exist.

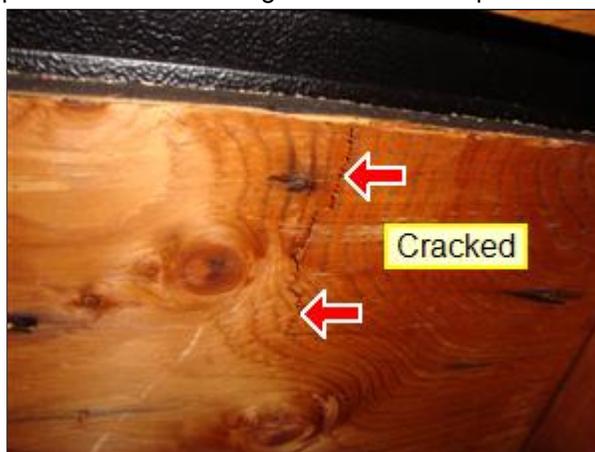
4.5 Picture 1

(1) The plywood sheathing sags and cracked in areas. Area still remains strong. It is not cost effective to replace until next roof. A qualified contractor should repair as needed. The sheathing is 3/8" sheathing and is typically not good for the life of the house. Budget for replacement of sheathing at time of roof replacement.

(1) The plywood sheathing sags and cracked in areas. Area still remains strong. It is not cost effective to replace until next roof. A qualified contractor should repair as needed. The sheathing is 3/8" sheathing and is typically not good for the life of the house. Budget for replacement of sheathing at time of roof replacement.

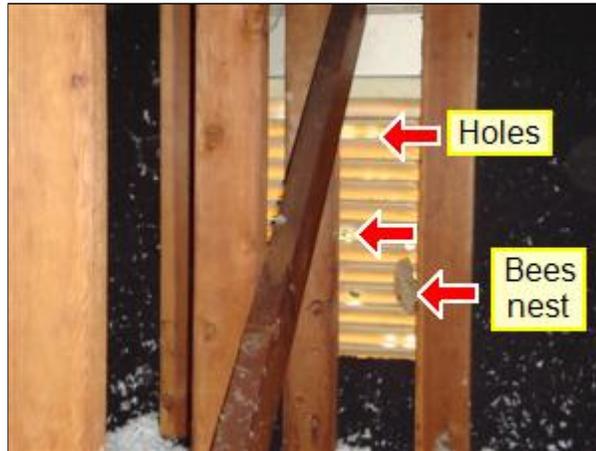
4.6 Picture 1

gable vent is damaged at the right side (facing front). Further deterioration may occur if not repaired bees are entering attic. A qualified contractor should inspect and repair as needed.

gable vent is damaged at the right side (facing front). Further deterioration may occur if not repaired bees are entering attic. A qualified contractor should inspect and repair as needed.

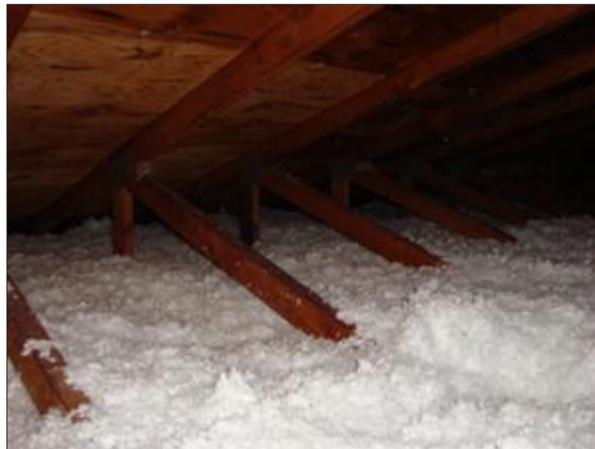
4.7 Picture 1

Additional insulation has been added to attic. This attic is well insulated.

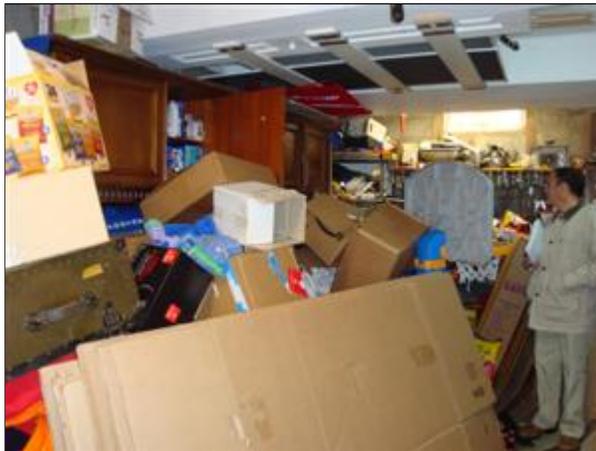
5.0 Picture 1

Unable to completely inspect garage walls due to personal possessions throughout garage.

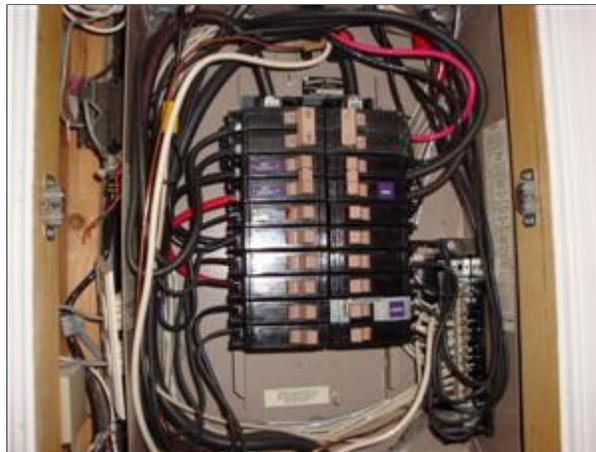
6.2 Picture 1

Aluminum wire is installed on 120 VAC branch electrical circuits in the subject house. These single strand, branch circuit aluminum wires were used widely in houses during the mid 1960s and 1970s. According to the U.S. Consumer Product Safety Commission, problems due to expansion can cause overheating at connections between the wire and devices (switches and outlets) or at splices, which has resulted in fires. For further information on aluminum wiring contact the U.S. Consumer Product Safety Commission via the Internet at <http://www.cpsc.gov/> . It is recommended that the electrical system be evaluated by a licensed electrician.

Aluminum wire is installed on 120 VAC branch electrical circuits in the subject house. These single strand, branch circuit aluminum wires were used widely in houses during the mid 1960s and 1970s. According to the U.S. Consumer Product Safety Commission, problems due to expansion can cause overheating at connections between the wire and devices (switches and outlets) or at splices, which has resulted in fires. For further information on aluminum wiring contact the U.S. Consumer Product Safety Commission via the Internet at <http://www.cpsc.gov/> . It is recommended that the electrical system be evaluated by a licensed electrician.

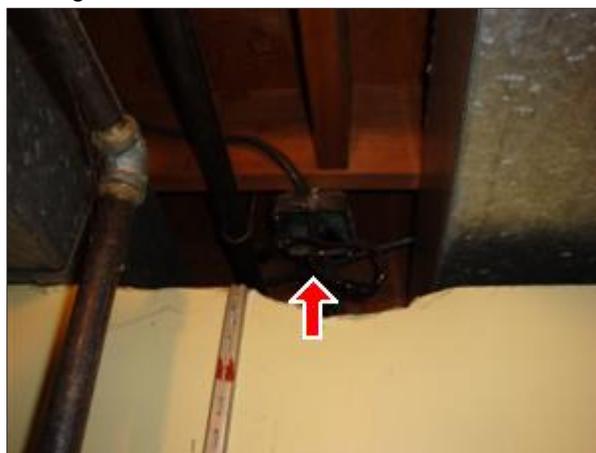
6.3 Picture 1

(1) One open splice needs a cover-plate overhead in the basement above washer/dryer. A qualified licensed electrician should perform repairs that involve wiring.

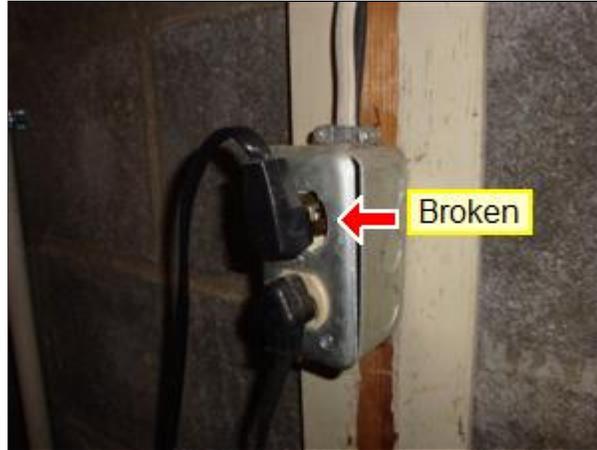
6.3 Picture 2

(2) One broken or damaged receptacle in the utility room at sump pump. This is a safety issue that needs to be corrected. A qualified licensed electrician should perform repairs that involve wiring.

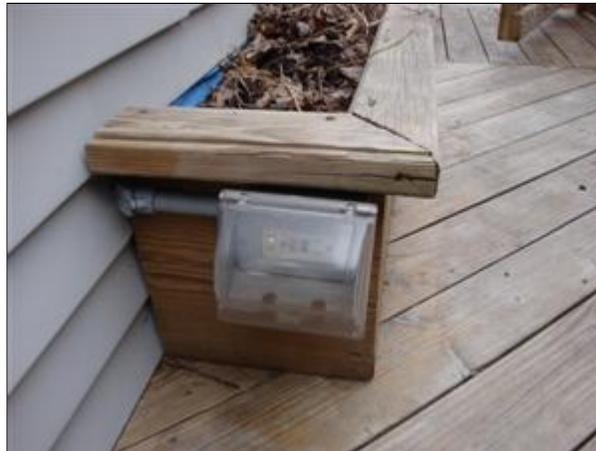
6.5 Picture 1

GFCI (Ground Fault Circuit Interrupter) outlet at the deck wont "trip" when tested. This is a safety issue that needs to be corrected. I recommend repair as needed.

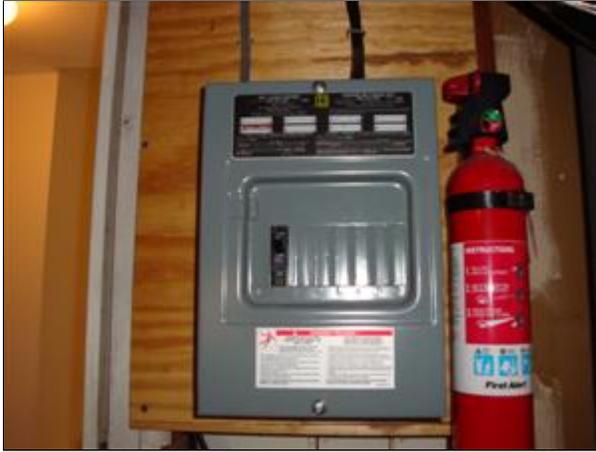
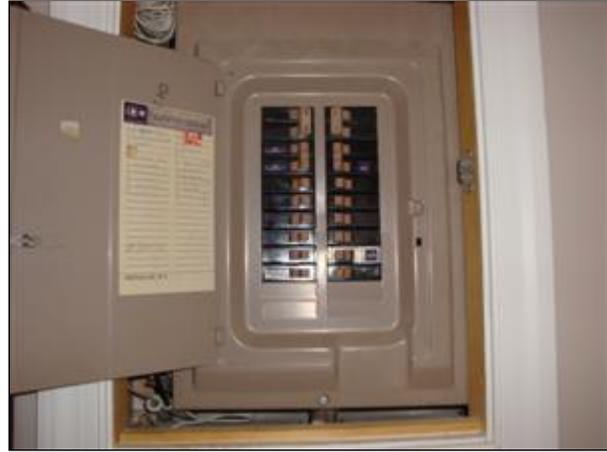
6.6 Picture 1

Main panel is located in family room and sub panel is located in utility room.

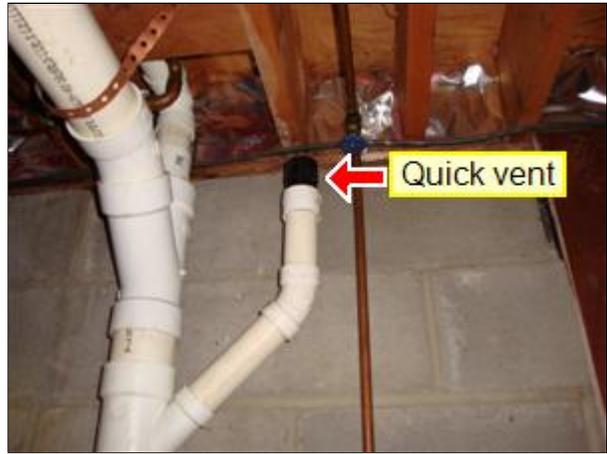
7.0 Picture 1

Quick vent used at waste line in basement. Some plumbing codes do not allow this type of mechanical vent. Consult a licensed plumber on this issue.

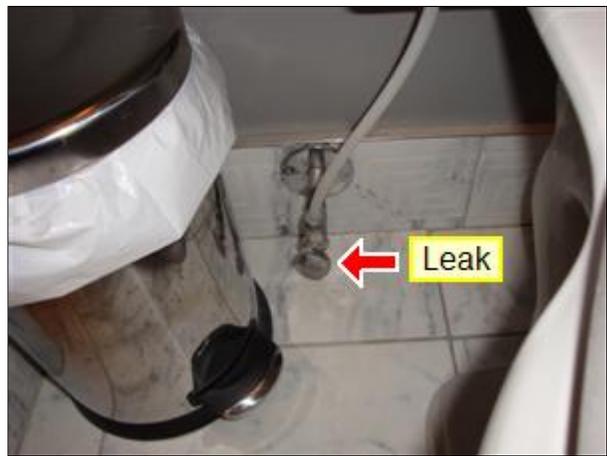
7.1 Picture 1

The cold supply line to toilet is leaking under the master bath. Repairs are needed. A qualified licensed plumber should repair or correct as needed.

The cold supply line to toilet is leaking under the master bath. Repairs are needed. A qualified licensed plumber should repair or correct as needed.

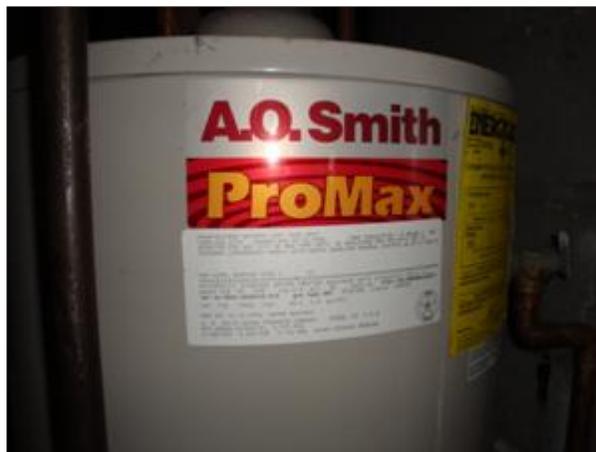
7.2 Picture 1

Water heater.

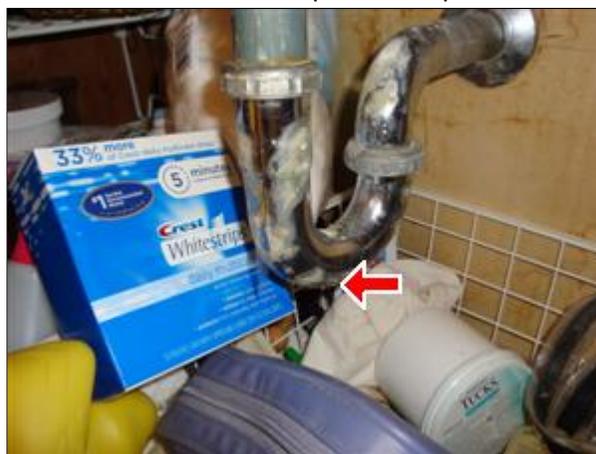
7.4 Picture 1

Corrosion to hall bath sink trap at waste line. Recommend replacement prior to leaking.

Corrosion to hall bath sink trap at waste line. Recommend replacement prior to leaking.

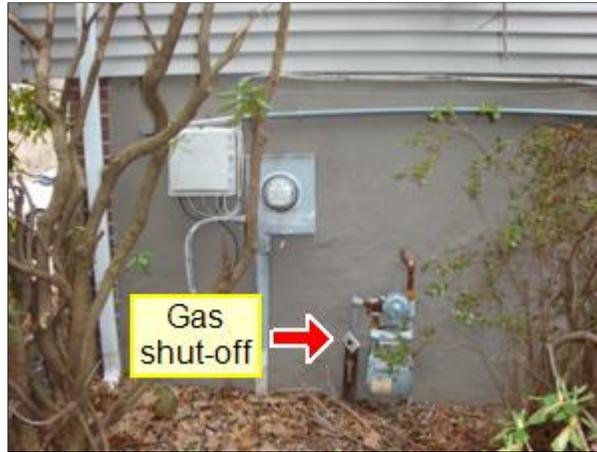
7.7 Picture 1

Main gas shut-off valve.

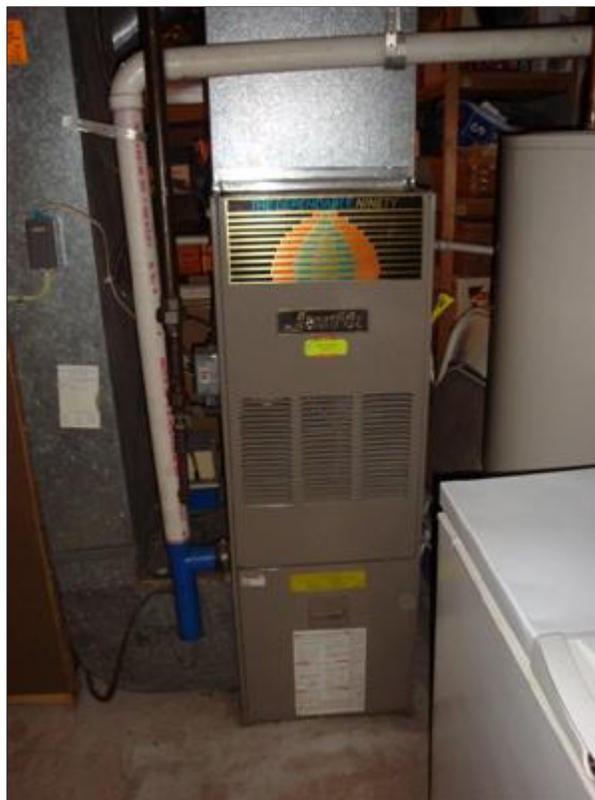
8.0 Picture 1

Gas fired furnace.

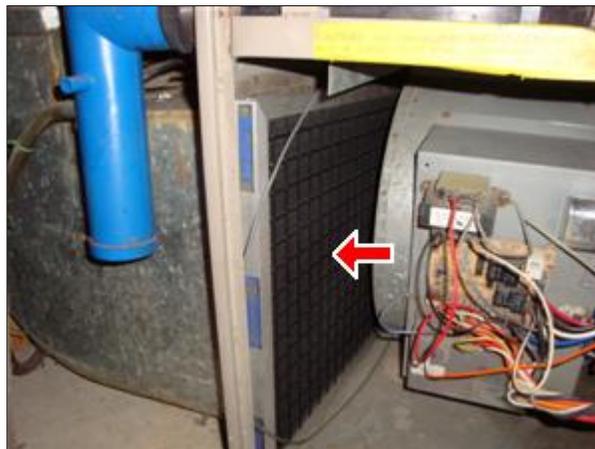
8.3 Picture 1

Filter location (see photo). Inside bottom of furnace.

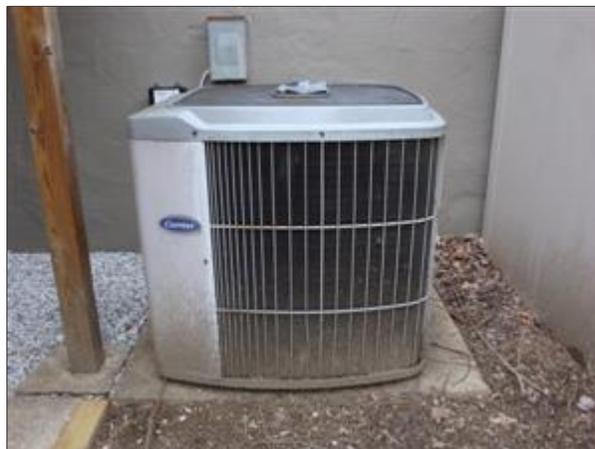
8.7 Picture 1

(1) The A/C was not tested for proper operation due to the outside air temperature is 65 degrees or less. We did not inspect this unit(s).

Unit is 13 years old and 2 1/2 tons.

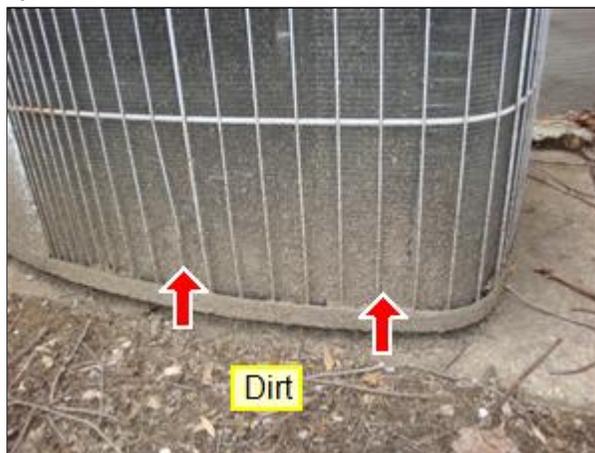
8.7 Picture 2

(2) Recommend stabilizing soil with plastic and stones around AC unit to prevent coil from accumulating dirt which will cause the unit to operate inefficiently.

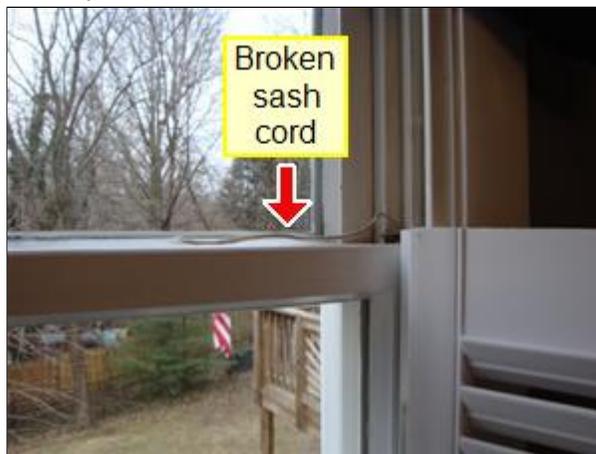
9.3 Picture 1

(1) One window missing sash cords at the Master bath. This is a maintenance issue and is for your information. A qualified contractor should inspect and repair as needed.

(1) One window missing sash cords at the Master bath. This is a maintenance issue and is for your information. A qualified contractor should inspect and repair as needed.
